Galt Joint Union Elementary School District

RE: Asbestos Hazard Emergency Response Act (AHERA) Asbestos Inspections and Management Plans

ENTEK CONSULTING GROUP, INC.

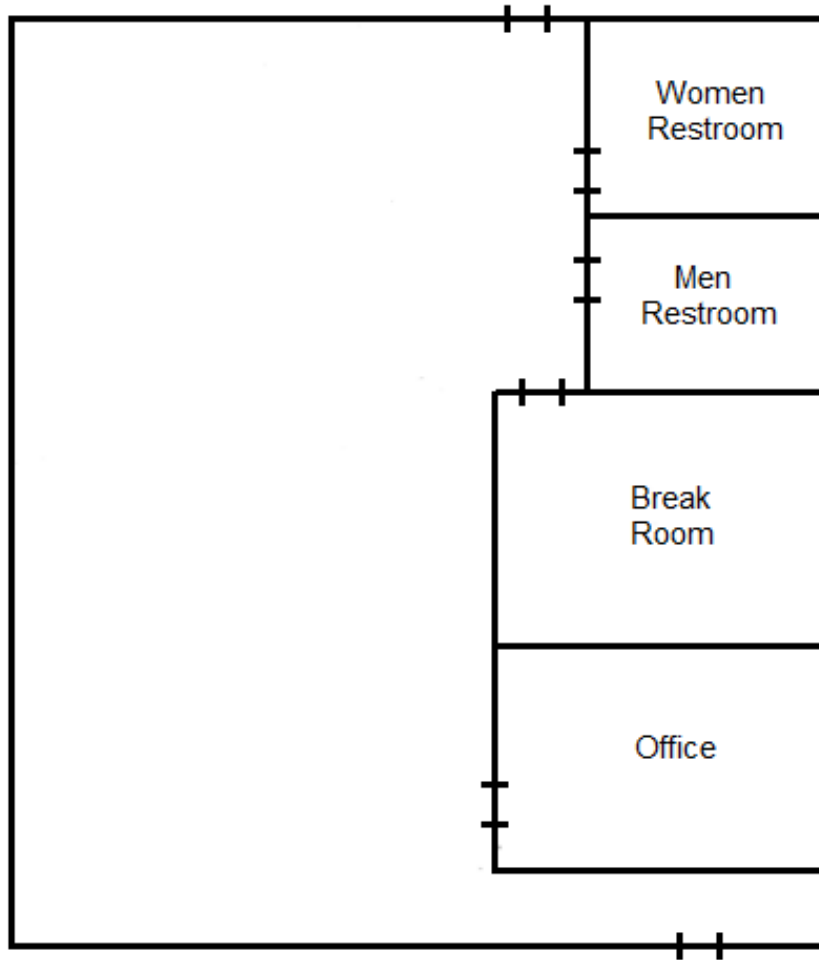
Galt Joint Union Elementary School District
Bus Garage
1019 Beaver Park Way
Galt, CA 95632

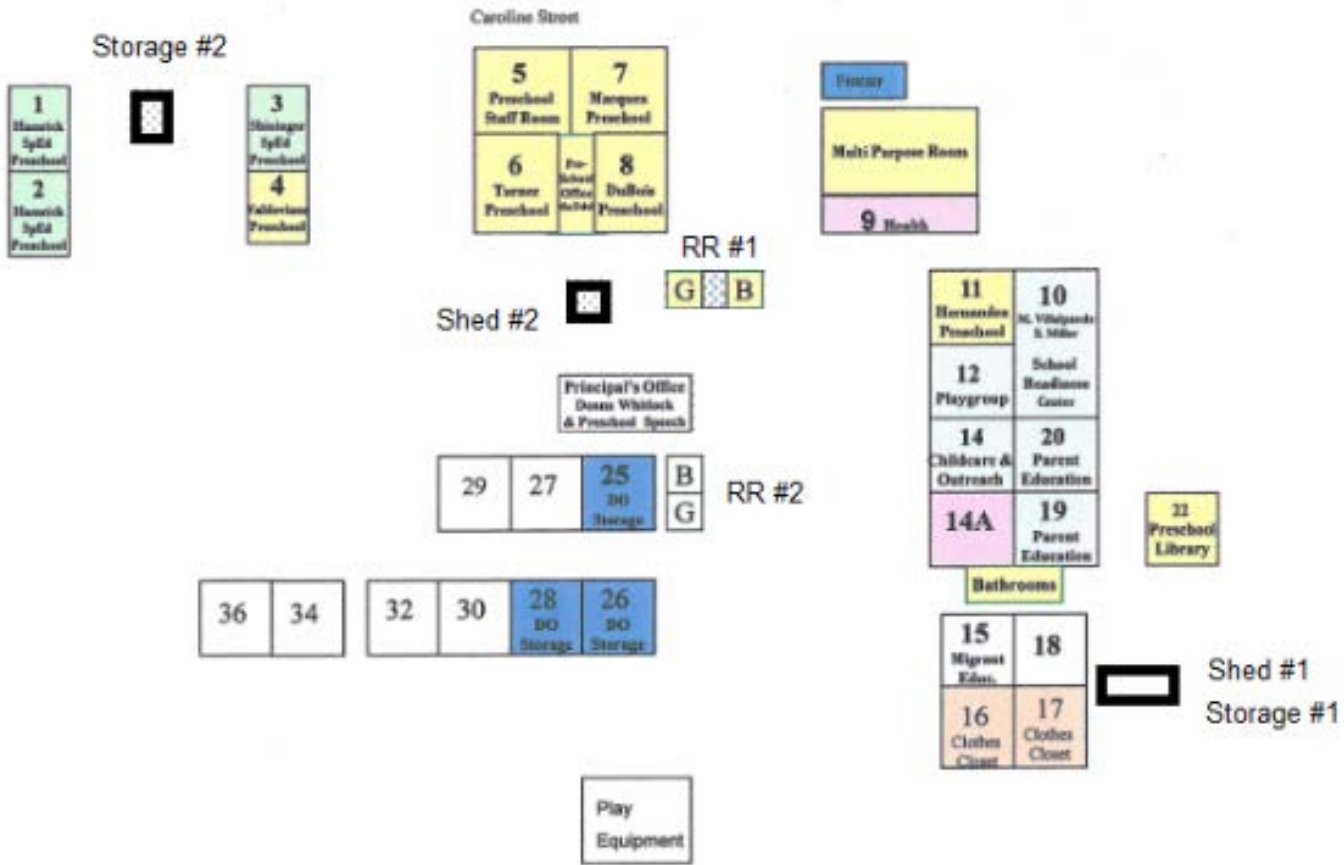
Fairsite Pre School

Galt Joint Union Elementary School District
Fairsite Preschool
902 Caroline Avenue
Galt, California 95632
